PHOTOGRAPHIC INTERPRETATION REPORT

SOUTHEAST ASIA ACTIVITY REPORT

SELECTED TRANSPORTATION AND INFILTRATION COMPENDIUM 26 JULY 1967

NPIC/R-138/67 AUGUST 1967

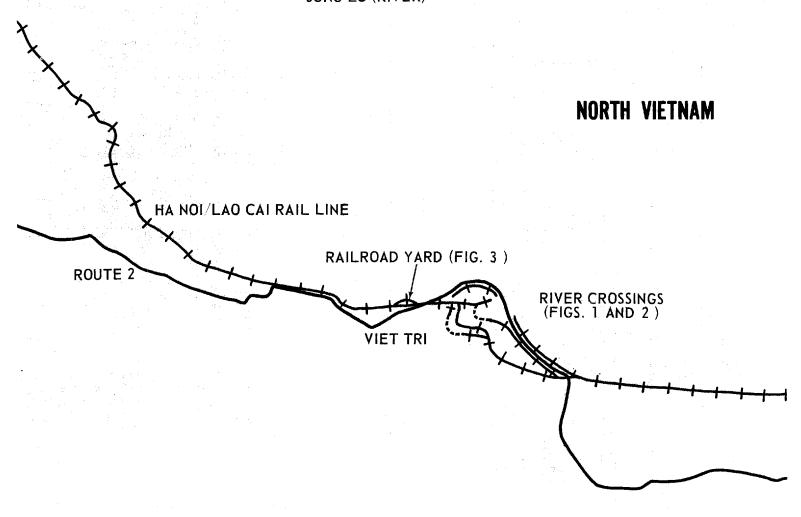
FIGURE 2. VIET TRI RAIL FERRY CROSSINGS, RIVIERE CLAIRE, NORTH VIETNAM

The Ha Noi/Lao Cai rail line is completely serviceable with the only break in the line occurring at Viet Tri where one of three ferry crossings is serviceable (Figure 2).

The rail ferry slips at UTM WJ462550 and WJ464549 are now unserviceable and in disuse. Two low water rail ferry slips at WJ458549 and WJ461548 are presently inundated, while the high water slips at WJ461548 and WJ459549 are serviceable. Sixteen pieces of rolling stock were located on the southeast approach on photography of

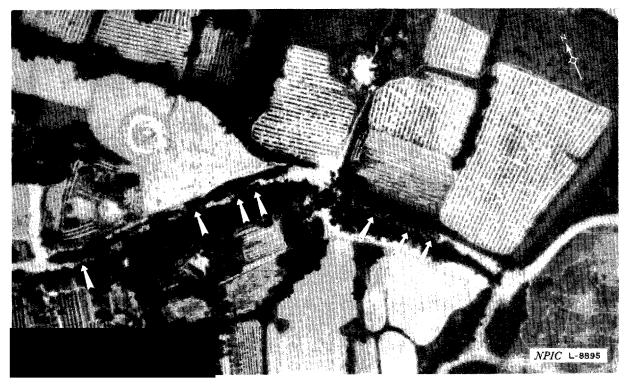
FIGURE 4. PARKED TRUCKS, ROUTE 1A AREA, NORTH VIETNAM

Seventeen trucks are observed near and in the village of Gieng Vot at 18-04N 106-18E, approximately 22 nm northwest of Ron (Figures 4 and 5).

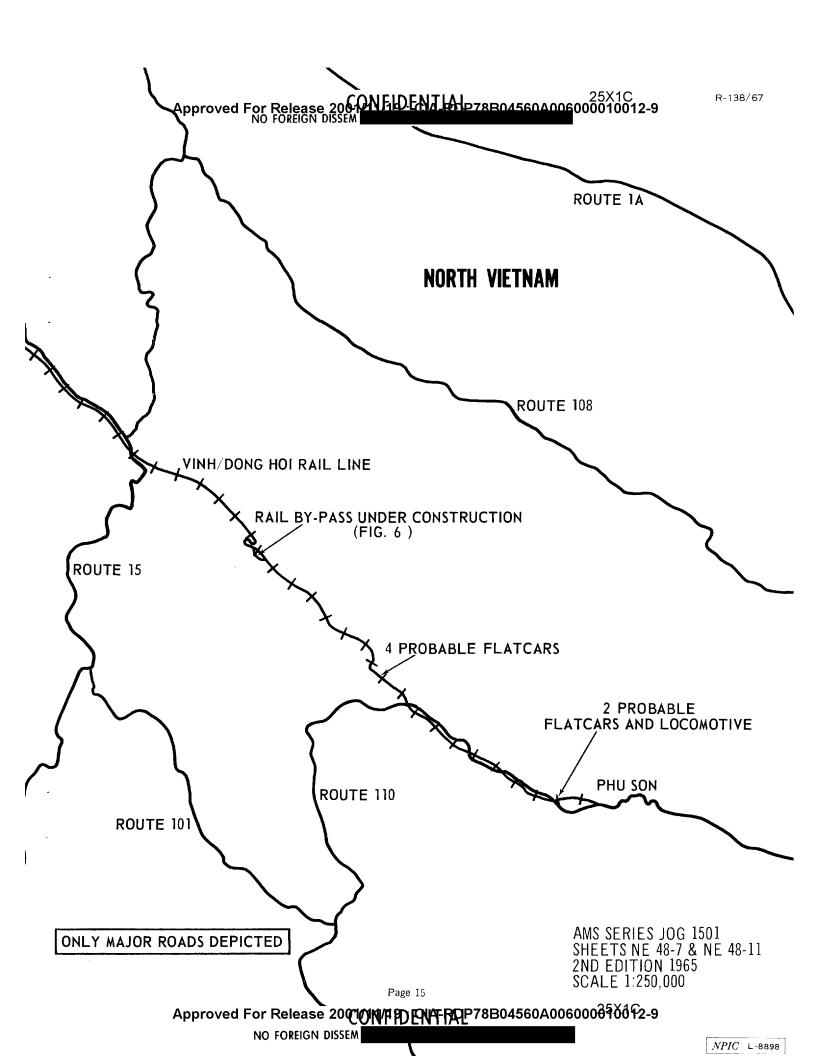
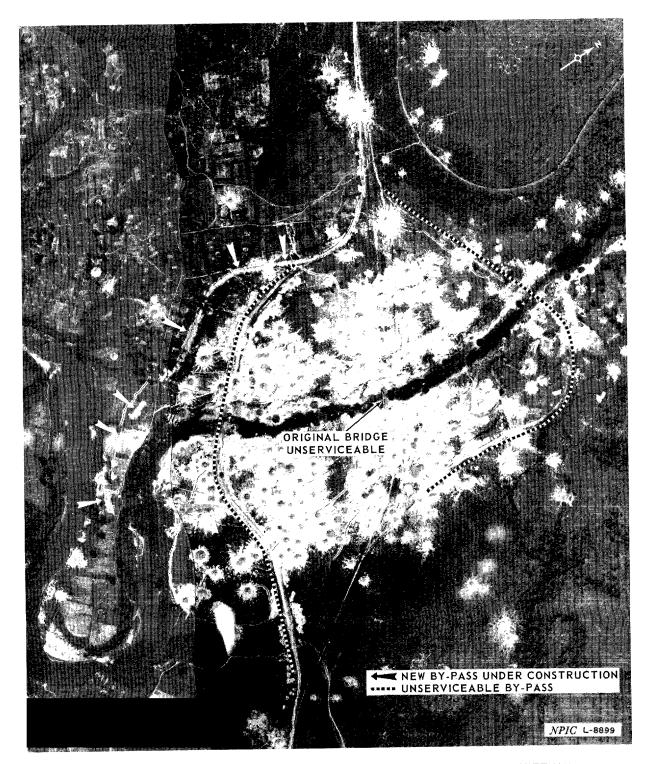
FIGURE 6. RAILROAD BY-PASS UNDER CONSTRUCTION, XOM KHE, NORTH VIETNAM

3. Activity on Vinh/Dong Hoi Rail Line, Nom hae, North Vietnam A new by-pass on the Vinh/Dong Hoi Rail time is in an early stage of construction at 17-58N 105-55E near Nom Kh: (Figure 6). South of the 25X1A heavily damaged Xom Khe Railroad Bridge and two unserviceable by-passes, the new by-pass will a parently cross the Khe Net (stream) in the vicinity of UTM WE986873. 25X1D The southern operational terminus of the rail line on was 17-49N 106-08E (XE213710) near Phu Son, representing an extension of 25X1D 0.5 nm since One short spur convained 4 probable flatcars 25X1D located at 17-53N 106-01E (XEO72791) and another short sour at 17-49N 106-07E (XE179712) had two probable flatcars and a camouflaged probable locomotive. Both spurs are partially concealed by natural vegetation.

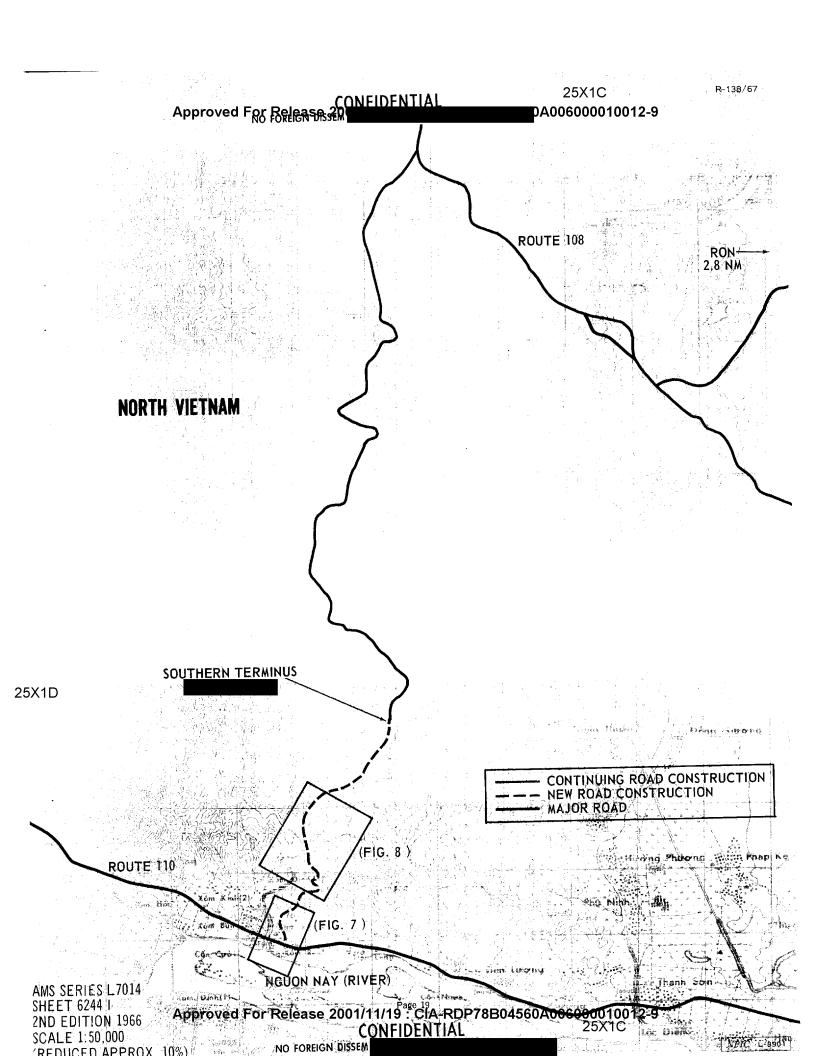
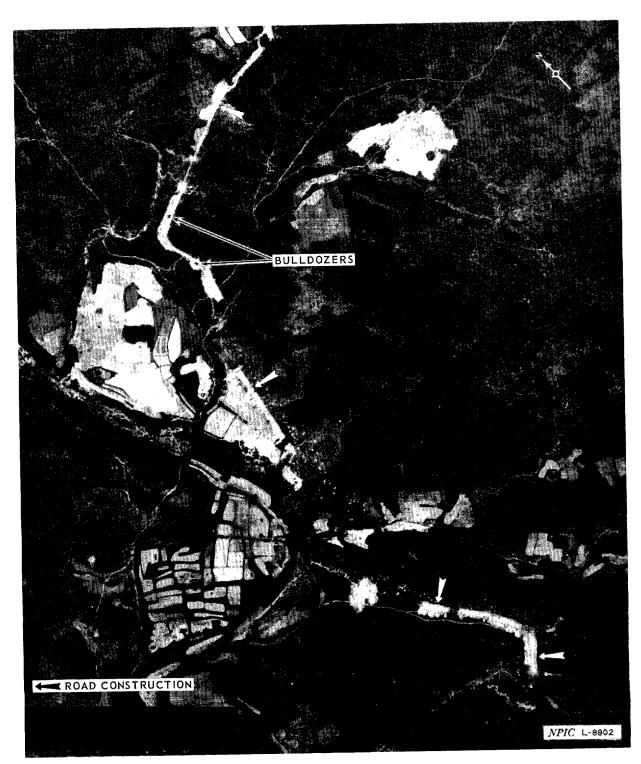
FIGURE 8. ROAD CONSTRUCTION, ROUTE 108/110 AREA, NORTH VIETNAM

Construction continues on the unnumbered road which extends south From Route 108 at 17-52N 106-21E to a present terminus 100 yards north of Route 110 at 17-46N 106-20E (Figures 7 and 8) segment which terminated at 17-47N 106-21E or 49) has reached middle-to-late stages while the new construction consists of initial clearing and grading operations. Alldozers were again observed in the construction area,

ROUTE 110 NGUON NAY (RIVER) PRESENT SOUTHERN TERMINUS OF ROAD CONSTRUCTION

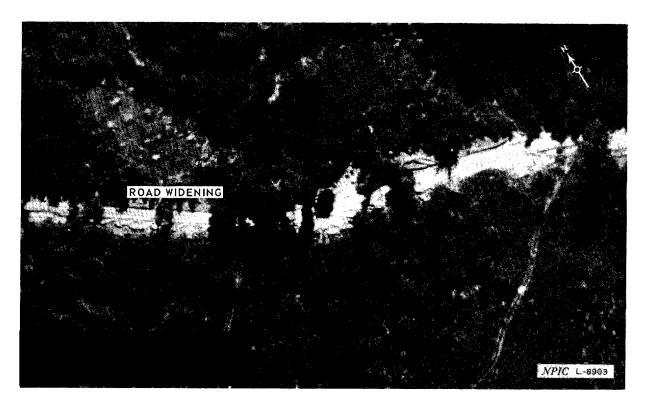
FIGURE 9. ROAD IMPROVEMENT, ROUTE 194, CAMBODIA

A 1.2 nm segment of Route 194 at 13-52N 106-55E (between UTM YA063354 and YA082344) is being widened and improved (Figure 9). Numerous parking areas for construction equipment are located along the road.

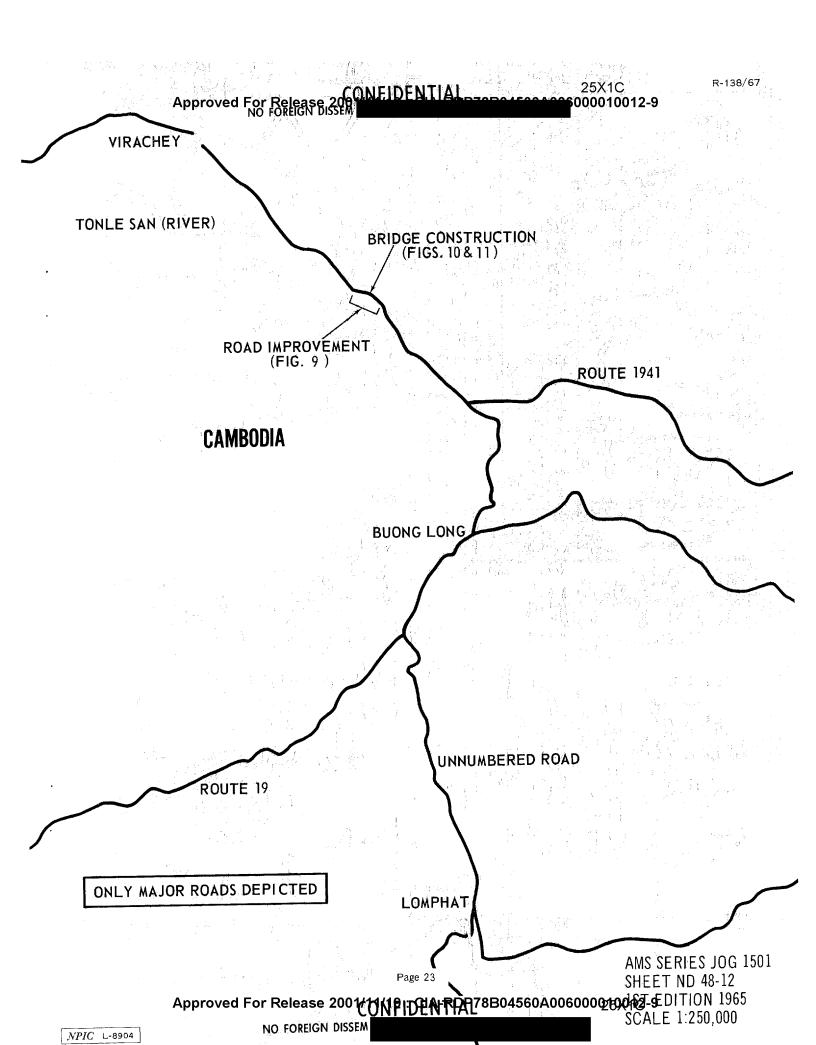
A wooden bridge 7.2 nm southeast of Virachey at YAO74352, observed in an early stage of construction on is now in middle-to-late stages of construction (Figure 11). No evidence of construction was observed on (Figure 10).

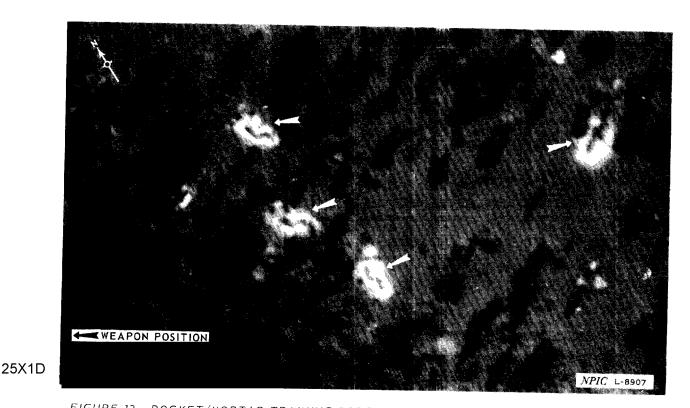
FIGURE 12. ROCKET/MORTAR TRAINING POSITIONS, TONLE SAN (RIVER) AREA, CAMBODIA

A probable rocket/mortar training area is located in Cambodia immediately east of the Tonle San River at 13-50N 107-23E. Approximately 38 weapons positions of the type in Figure 12 (also see artist conception Figure 13) are located within an area bounded by UTM YA562317, YA584317, YA584292, and YA562292. The revetments consist of a personnel bay

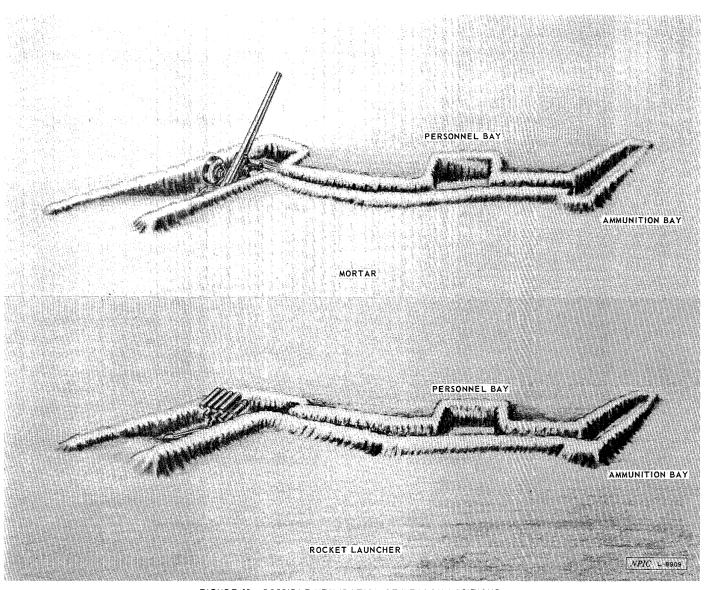
FIGURE 13. POSSIBLE UTILIZATION OF WEAPON POSITIONS

25X1D 25X1D 25X1D an ammunition bay
for this type of position would include the trailer-mounted 140-mm
rocket launcher (BM 14-16), or a modification of that weapon, and the
160-mm mortar (M-160). Thus far, however, no weapons or associated equipment have been observed on photography.

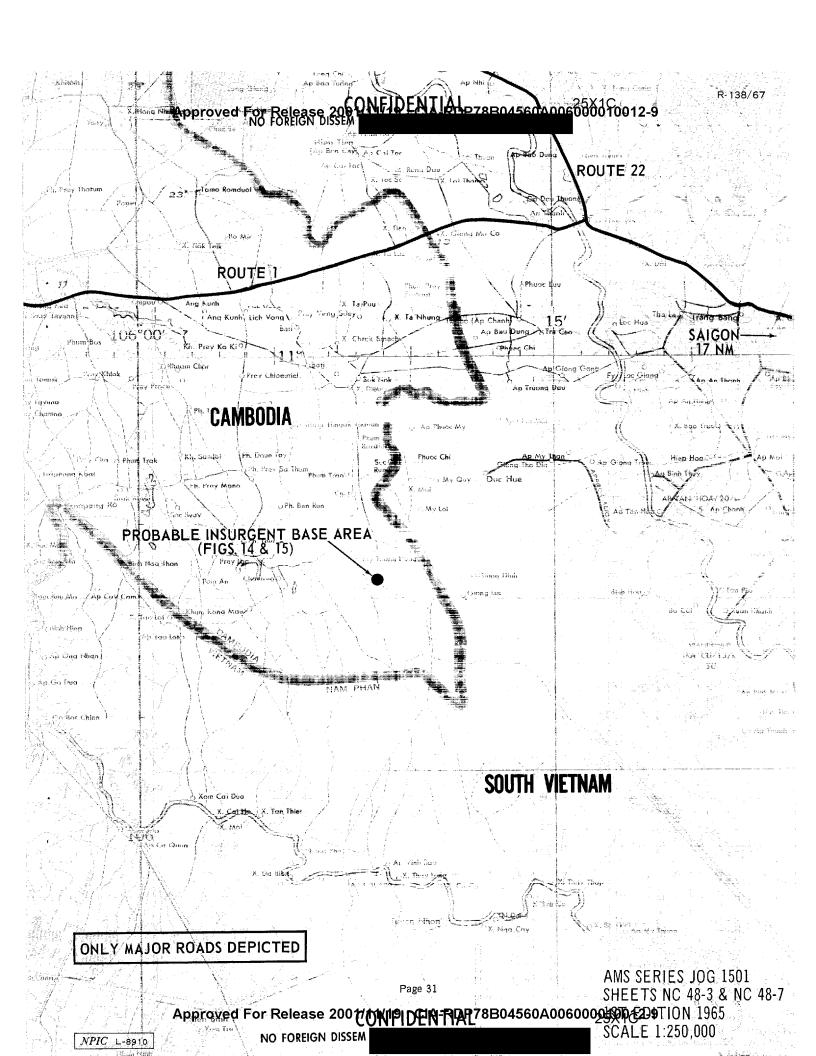
Increased activity is observed in the previously reported probable base area (Summary No 50, Item 4, Figures 13, 16, and 17) at 10-52N 106-08E in Sway Rieng Province, Cambodia, approximately 1.3 nm west of the Cambodia/South Vietnam Border. At least 40 new buildings and numerous new defense positions have been built since in an area bounded by UTM XT245025, XT265025, XT245010, and XT265010 (Figures 14 and 15).

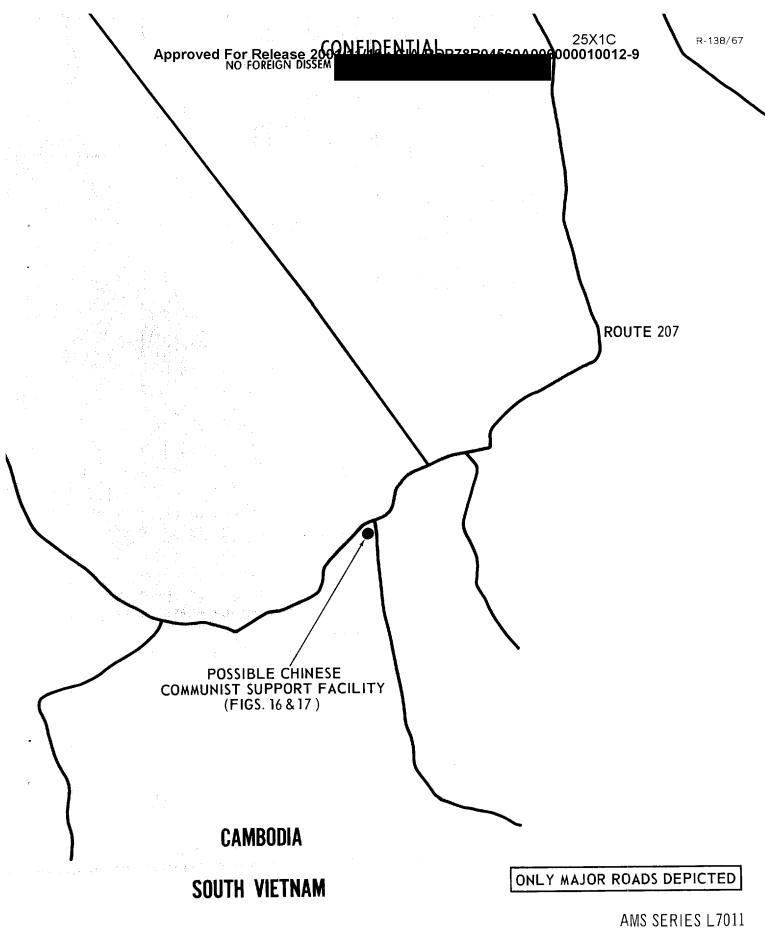
There has been a significant increase in activity associated with the previously identified possible Chinese Communist Support Facility (Summary No 44) at 10-32N 104-51E (UTM VS839671), immediately northwest of the Cambodia/South Vietnam border (Figures 16 and 17).

Several foxholes, a trench system, and three newly constructed buildings are identified within the immediate area. At least five buildings and one shed have been dismantled.
